Stream Gage Repairs

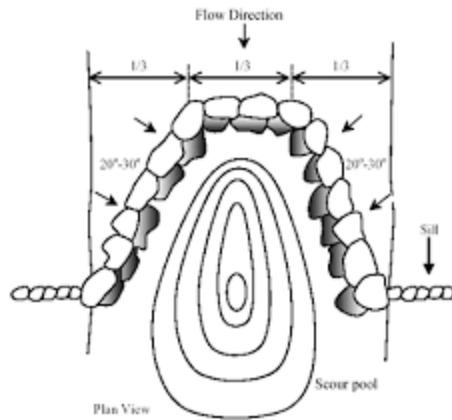
In May of 2017, high flows severely damaged two measurement gages on the Cucharas River (Boyd Ranch and Harrison Bridge). HCWCD acted as fiscal agent for Division of Water Resources funding for a local contractor to construct two protective cross vane weirs at those gage locations. Built with two angled lines of boulders forming a “U,” with the closed end pointed upstream, the weirs operate on the principle that water

crosses a barrier perpendicular to the barrier. Consequently, they direct water away from the stream banks and direct it down the middle of the channel to the gage as shown in the schematic and in the accompanying photo of the new weir at the Harrison Bridge gage.
